**Flood Control Project Maintenance  
Levee Inspections**  
**LMA District Cover Sheet**  
**Spring 2020 Levee Inspection Results**

**American River Flood Control District**

**Spring 2020 Levee Inspection Results**

Waterway			Bank	Unit Miles
Unit No. 01 Arcade Creek			Left	2.08
	Spring (March - May)	Summer (June - August)	(September - November) Fall	Winter (December - February)
Unit Maintenance Rating (Fall Only)				
Date of Inspection	3/25/2020 - 3/25/2020			
DWR Inspector	Luz Dial			
Accompanied By	Gilbert Gutierrez ARFCD

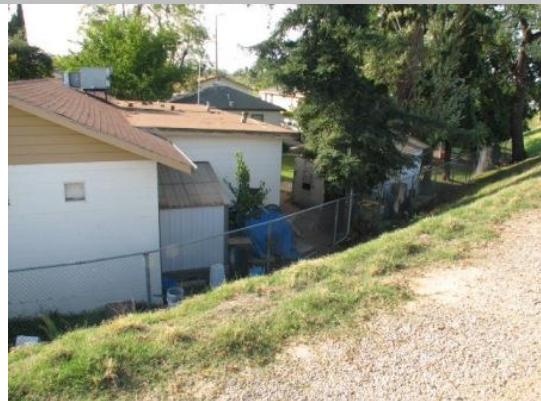
Photo 1 of 1 : SP\_2020\_NA0001\_51\_18\_20200302\_00014.jpg

Fall 2009 photo: Buildings and fence near levee toe.

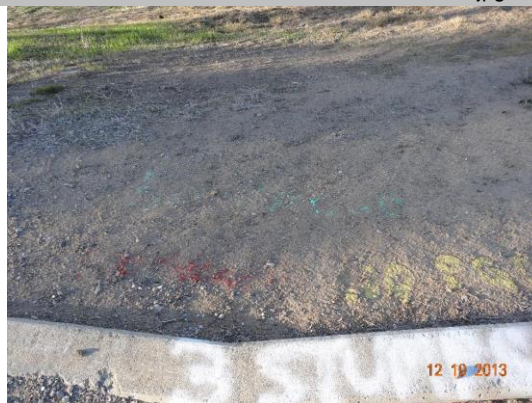
Photo 2 of 3 : UCIP\_SP\_2020\_30085\_55488.jpg

Underground service alert (USA) paint markings visible on waterward slope.

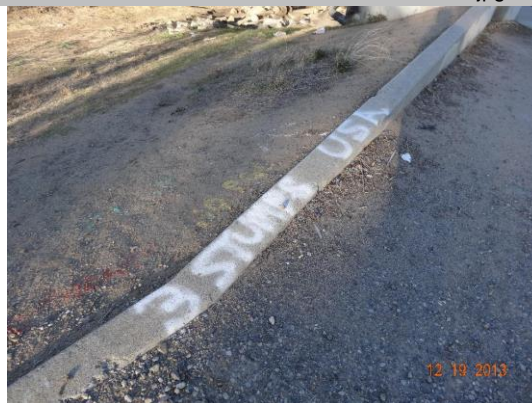
Photo 3 of 3 : UCIP\_SP\_2020\_29732\_54977.jpg

Floodwall visible along waterward shoulder.

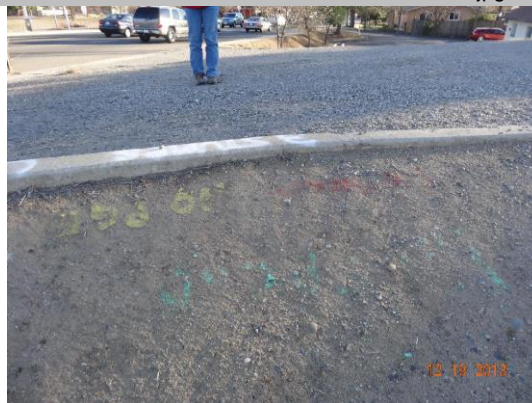
Photo 3 of 3 : UCIP\_SP\_2020\_53490\_75857.jpg

Underground service alert (USA) markings found on WS shoulder, photo 2 of 2.

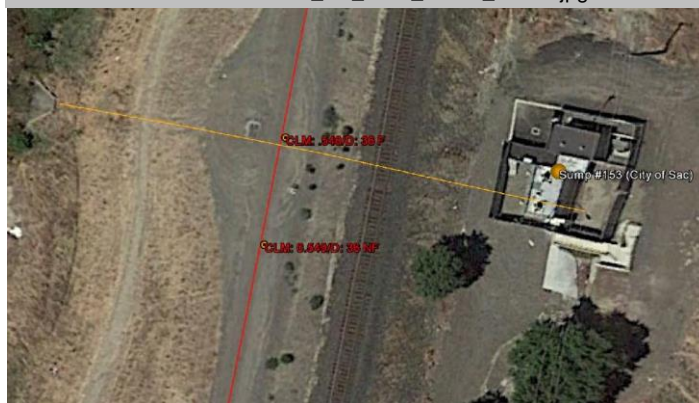
Photo 1 of 2 : UCIP\_SP\_2020\_51428\_75580.jpg

Approx. location of USACE O&M original 36-inch located 40 feet downstream from Sump 153.

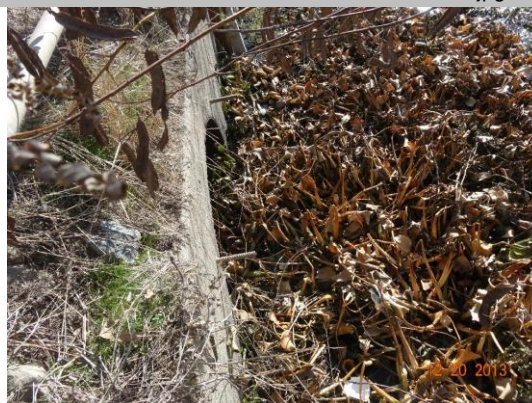
Photo 3 of 3 : UCIP\_SP\_2020\_53492\_52913.jpg

Gate missing for 3rd pipe on WS.

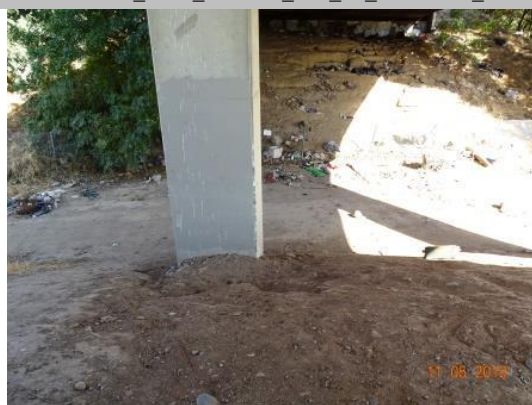
Photo 1 of 1 : SP\_2020\_NA0001\_490\_10\_20200302\_00001.jpg

View of footpaths around column for the overpass. Fall 2019

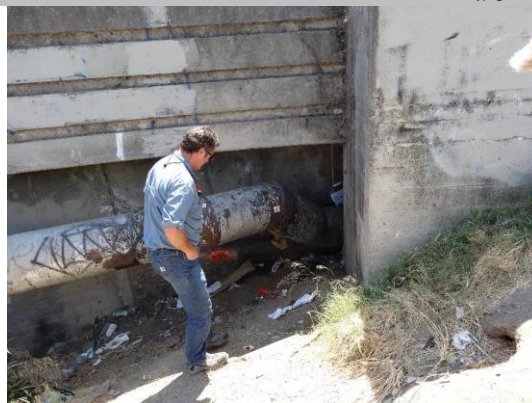
Photo 3 of 3 : UCIP\_SP\_2020\_53602\_75833.jpg

18-inch abandoned line and 8-inch gas line visible on WS.

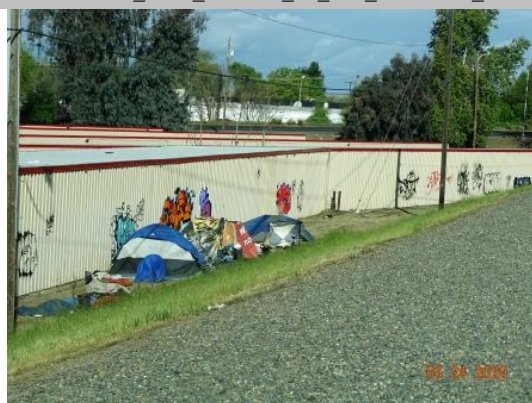
Photo 1 of 1 : SP\_2020\_NA0001\_55\_269\_20200427\_00272.jpg

View of tents at the landside toe. Spring 2020

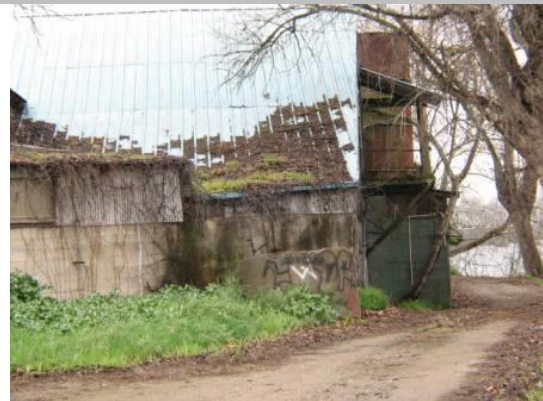
Photo 1 of 1 : SP\_2020\_NA0001\_55\_2\_20200302\_00001.jpg

03/16/2012 Structure on Bell Marine property.

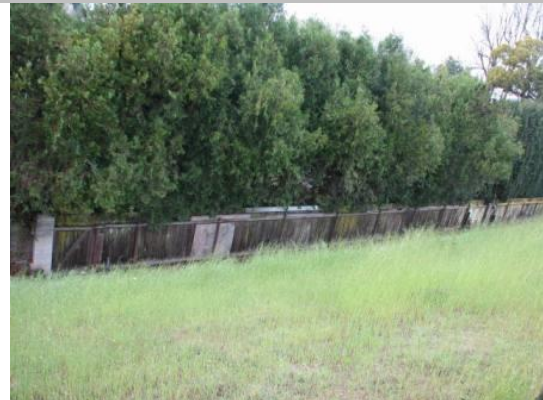
Photo 1 of 1 : SP\_2020\_NA0001\_55\_15\_20200302\_00011.jpg

03/16/2012 Wood privacy fence completely obstructs access and visibility.

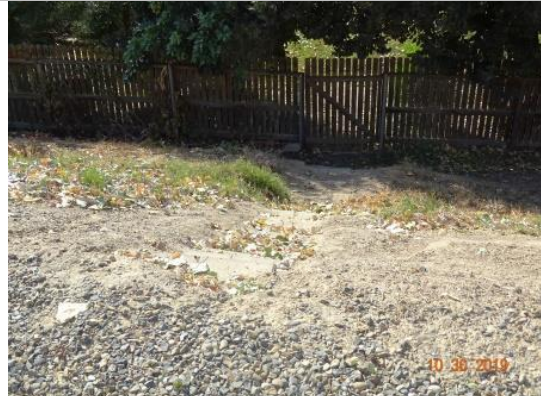
Photo 1 of 1 : SP\_2020\_NA0001\_55\_201\_20200302\_00161.jpg

View of wooden fence at the levee toe and concrete stairs on the slope. Fall 2019

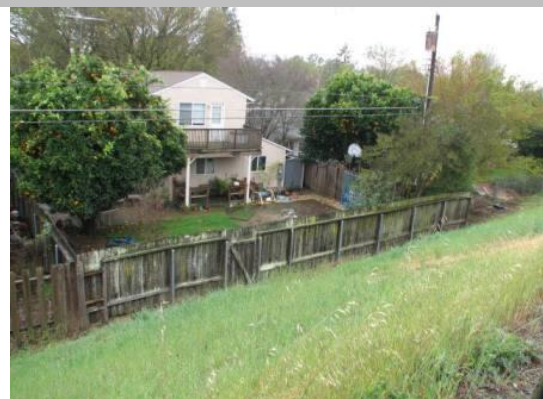
Photo 1 of 1 : SP\_2020\_NA0001\_55\_40\_20200302\_00030.jpg

03/16/2012 Wood privacy fence completely obstructs access and visibility.

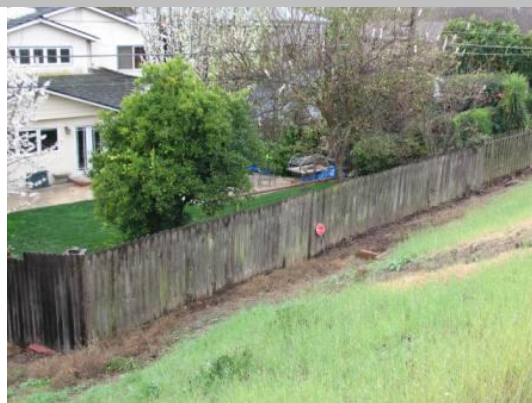
Photo 1 of 1 : SP\_2020\_NA0001\_55\_42\_20200302\_00032.jpg

03/16/2012 Wood privacy fence completely obstructs access and visibility.

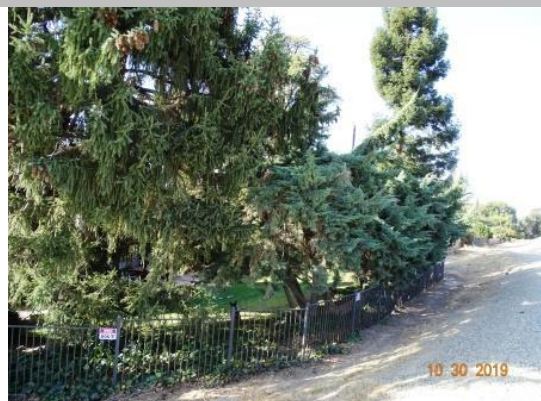
Photo 1 of 1 : SP\_2020\_NA0001\_55\_175\_20200302\_00140.jpg

View of wrought iron fence at the levee toe. Fall 2019

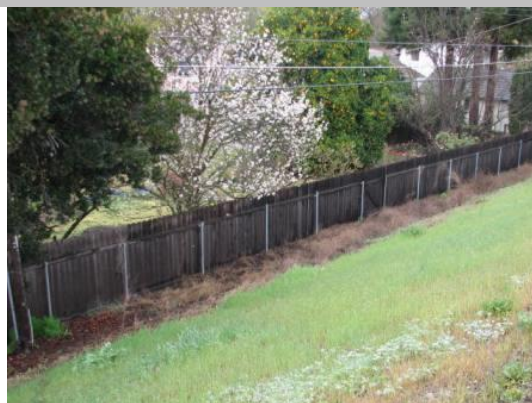
Photo 1 of 1 : SP\_2020\_NA0001\_55\_54\_20200302\_00042.jpg

03/16/2012 Wood privacy fence completely obstructs access and visibility.

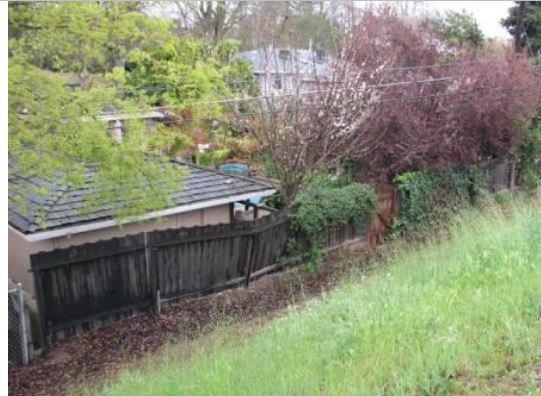
Photo 1 of 1 : SP\_2020\_NA0001\_55\_57\_20200302\_00044.jpg

03/16/2012 Wood privacy fence completely obstructs access and visibility.

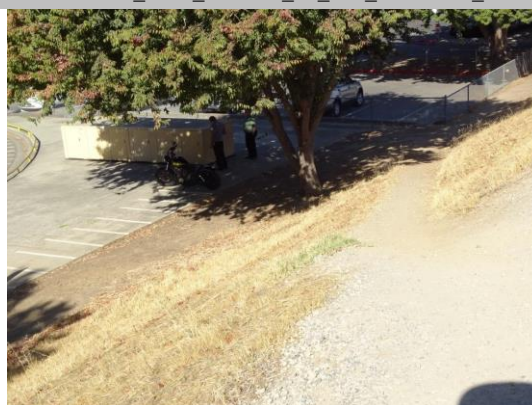
Photo 1 of 1 : SP\_2020\_NA0001\_55\_270\_20200302\_00200.jpg

View of footpath on slope. Fall 2018

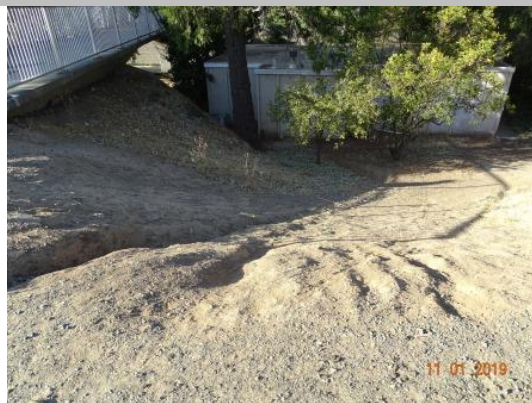
Photo 1 of 1 : SP\_2020\_NA0001\_55\_287\_20200302\_00204.jpg

View of erosion rills downstream of the Guy West Bridge. Fall 2019

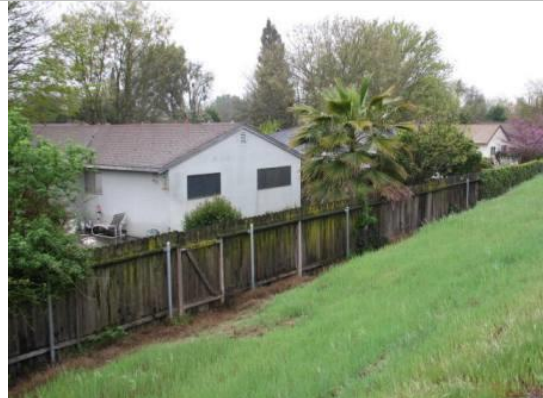
Photo 1 of 1 : SP\_2020\_NA0001\_55\_115\_20200302\_00095.jpg

03/16/2012 Wood privacy fence completely obstructs access and visibility.

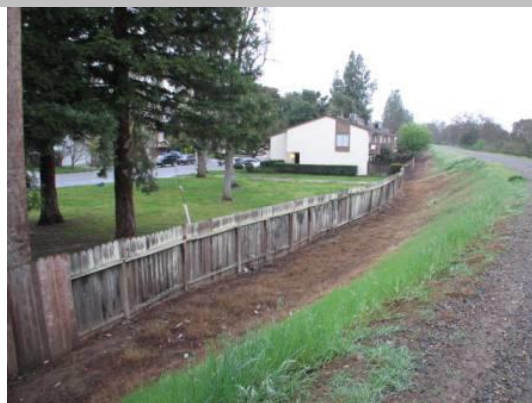
Photo 1 of 1 : SP\_2020\_NA0001\_55\_147\_20200302\_00116.jpg

03/16/2012 Wood privacy fence completely obstructs access and visibility.

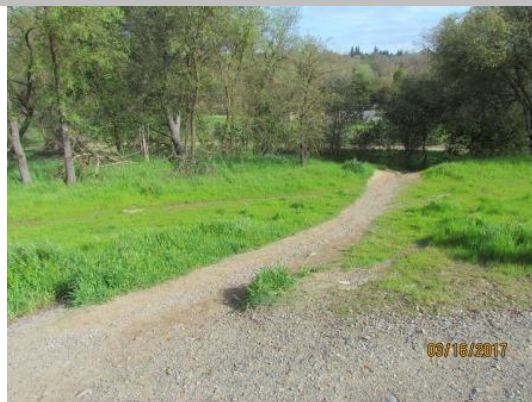
Photo 1 of 1 : SP\_2020\_NA0001\_55\_219\_20200302\_00174.jpg

View of the footpath on the levee slope.

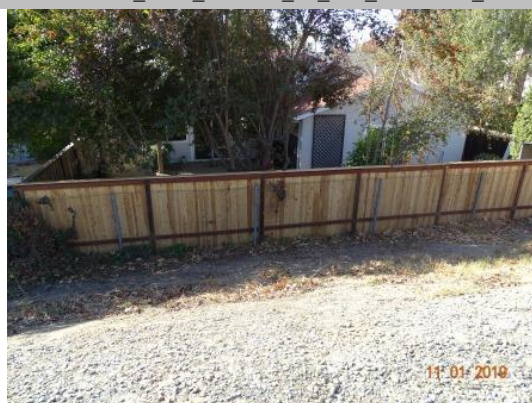
Photo 1 of 1 : SP\_2020\_NA0001\_55\_299\_20200302\_00205.jpg

View of a wooden fence on the levee easement. Fall 2019

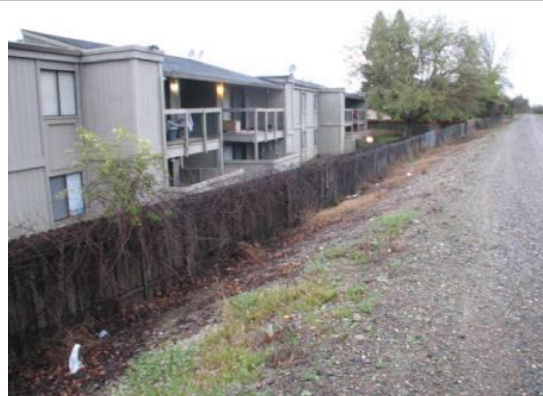
Photo 1 of 1 : SP\_2020\_NA0001\_55\_168\_20200302\_00135.jpg

03/16/2012 Wood privacy fence completely obstructs access and visibility.

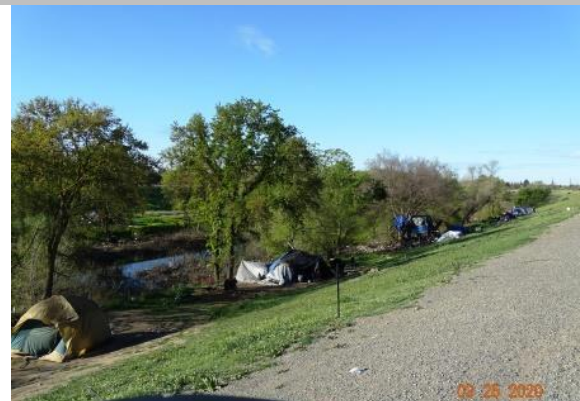
Photo 2 of 2 : SP\_2020\_NA0001\_58\_54\_20200326\_00067.jpg

View of camps located at the waterside toe. Spring 2020

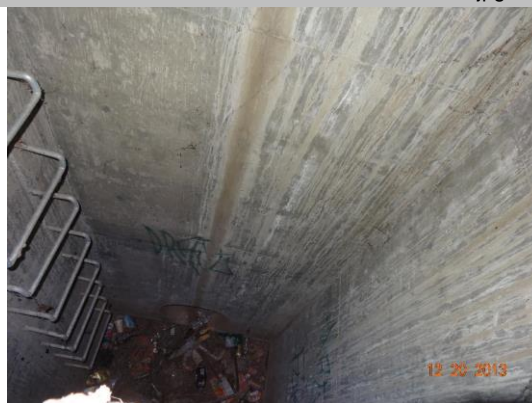
Photo 3 of 3 : UCIP\_SP\_2020\_29326\_54320.jpg

Inside view of concrete riser located on waterward shoulder--debris found at the bottom of riser.

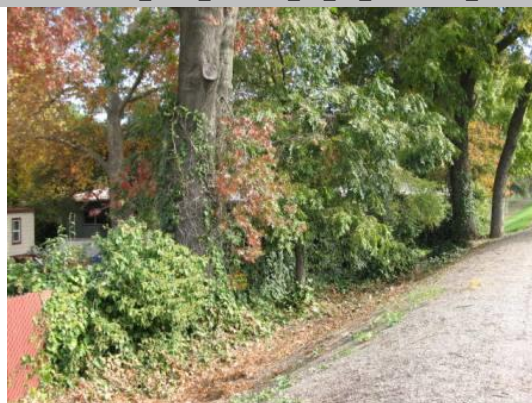
Photo 1 of 1 : SP\_2020\_NA0001\_58\_15\_20200302\_00013.jpg

11/17/2011 Dense vegetation at the toe.

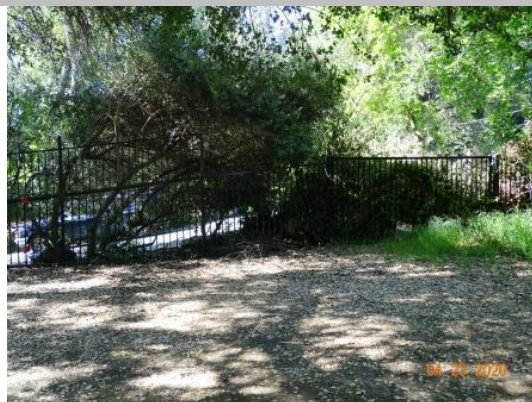
Photo 1 of 2 : SP\_2020\_NA0001\_61\_16\_20200508\_00035.jpg

View of private gate across the levee crown at LM 0.19. Spring 2020

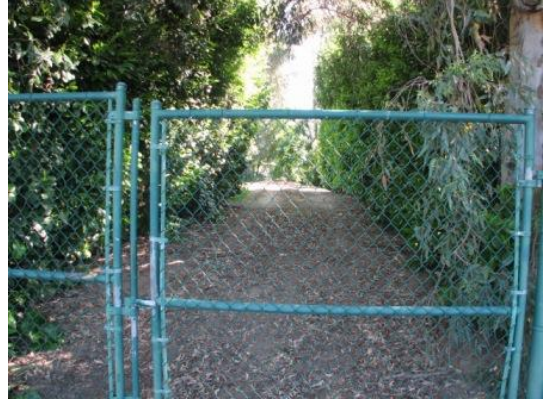
Photo 2 of 2 : SP\_2020\_NA0001\_61\_16\_20200302\_00003.jpg

This section is not reasonably accessible due to properties permitted on the levee crown.

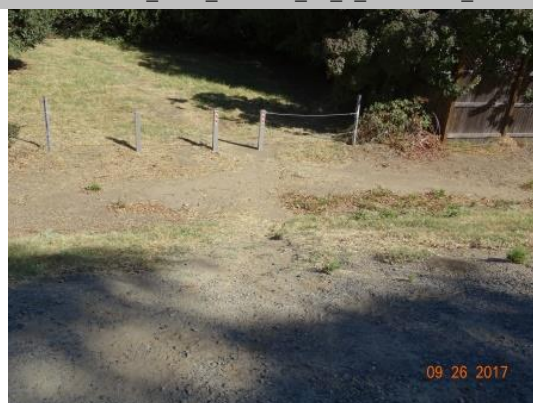
Photo 1 of 1 : SP\_2020\_NA0001\_61\_2\_20200302\_00001.jpg

View of the footpath on the levee slope. Fall 2017

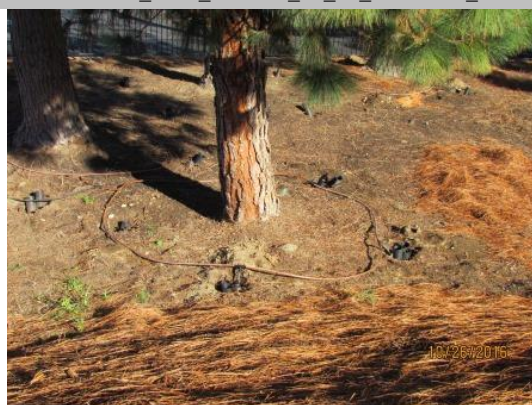
Photo 1 of 1 : SP\_2020\_NA0001\_61\_27\_20200302\_00008.jpg

View of the landscaping irrigation at the landside levee toe.

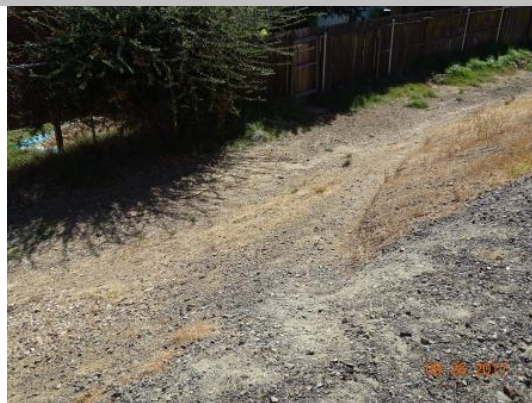
Photo 1 of 1 : SP\_2020\_NA0001\_438\_8\_20200302\_00002.jpg

View of the footpath on the levee slope.

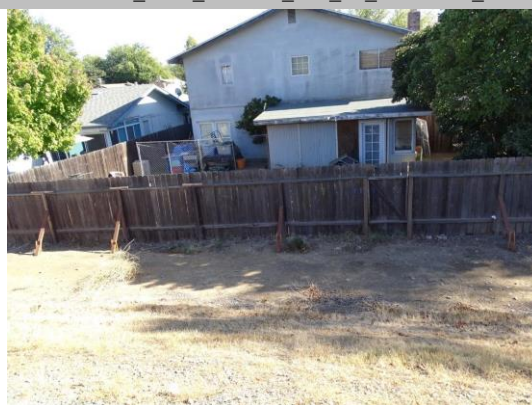
Photo 1 of 1 : SP\_2020\_NA0001\_438\_10\_20200302\_00003.jpg

View of fence bracing that partially blocks access. Fall 2018

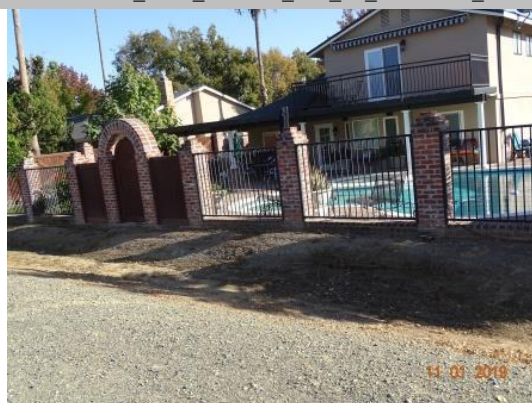
Photo 1 of 1 : SP\_2020\_NA0001\_438\_11\_20200302\_00004.jpg

View of pool within 100' of the levee toe. Fall 2019
